Community Pipeline Safety Initiative City of Lafayette

November 13, 2018

TREE-BY-TREE REVIEW IN LAFAYETTE

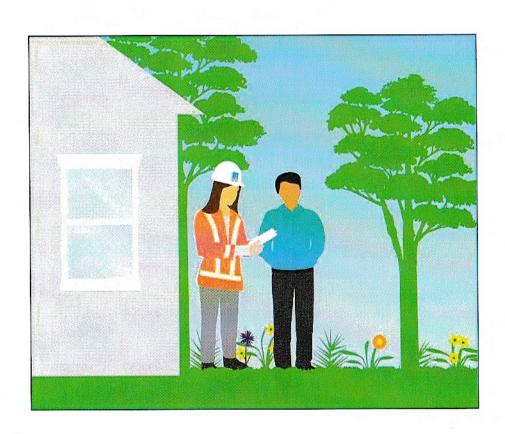
- In 2015, we initially identified more than 1,000 trees located up to 14 feet from the gas transmission pipelines in Lafayette
- Working together with the city arborist, we conducted a tree-bytree review and found that most trees could remain in place with ongoing monitoring; 272 trees were identified as posing a safety concern
- In 2017, we completed an additional review and confirmed that 207 trees are located too close to the pipeline and need to be replaced for safety reasons

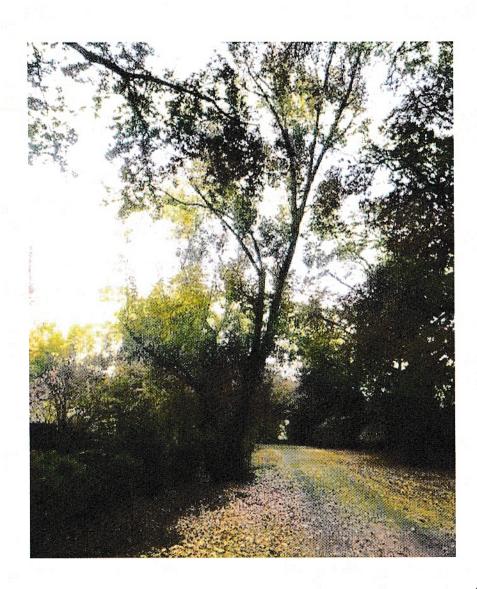
UNACCEPTABLE RISK TREE EXAMPLE

• Name: Line 191-1

Diameter: 12.75"

• MAOP: 497 psig

· Location: Lafayette, Calif.

· Tree Species: Cottonwood

Approx. Diameter at Breast Height: 42" (multistem)

• Approx. Distance to Pipe: 1'

· Approx. Depth of Cover: 32"

- · Distance to pipe
- · Depth of pipe
- · Lightning and wind exposure
- Ability to access the pipeline for maintenance work
